Technical Bulletin / Safety Alert

Unique ID No: DES2012-TBSA-04

Subject: MDR090376DES Exhaust System - Incident Notification

Applicable to: VLI Diesel Pty Ltd Diesel Engine Systems covered under design registration no. MDR 090376 DES (Driftrunner & Brumby)

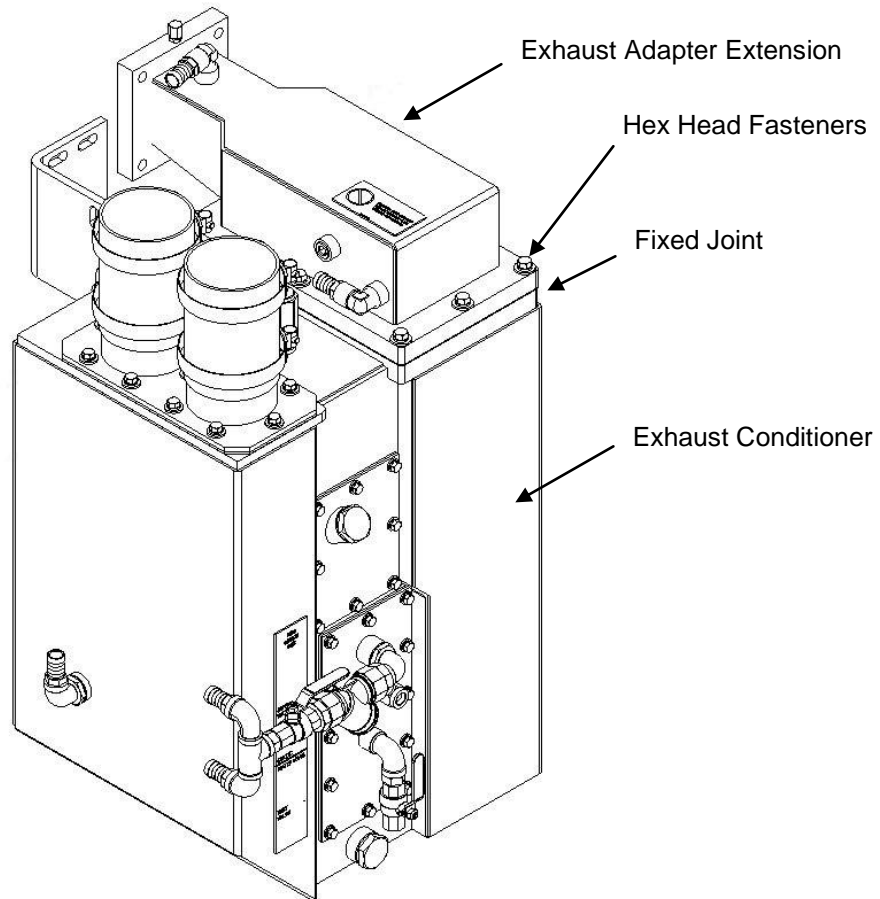
Figure 1: MDR090376DES Exhaust Conditioner Assembly

The incident occurred at a NSW Coal Mine, during a weekly service inspection, when the end user detected a leaking joint between the water based exhaust conditioner and the exhaust adaptor extension.

Examination of the exhaust conditioner and exhaust adapter extension returned to VLI identified that machining to the mounting flange on the exhaust conditioner tank had reduced the depth of one of the threaded bolt holes to the minimum nominated tolerance; subsequently the bolt appeared to have become thread bound at this location, resulting in the reported leaking joint. It was considered likely that the joint integrity was intact on initial installation, and that subsequent in-service thermal cycling had resulted in the failure of the joint integrity.

Upon review of the exhaust conditioner tank to exhaust adapter extension assembly design and the allowable minimum tolerances of the component flanges, it was identified that there is potential for the thread engagement of the nominated bolts to render them thread bound. To address this potential, it is the intention of VLIDD to revise the requirements for the threaded fasteners used between the exhaust adapter extension and the exhaust conditioner tank, such that the hex head bolts currently used at this location be replaced with studs.

VLIDD are in the process of preparing an application for an alteration to the registered design, to provide for replacement of the hex head bolts with studs at the joint between the exhaust adapter extension and the exhaust conditioner tank. On completion of this process an updated TBSA will be released to industry.
